Warning Signs Litigation & Issues

A presentation to the
Society of Public Insurance Administrators of Ontario
by
Brian Anderson, Road Specialist, Frank Cowan Company

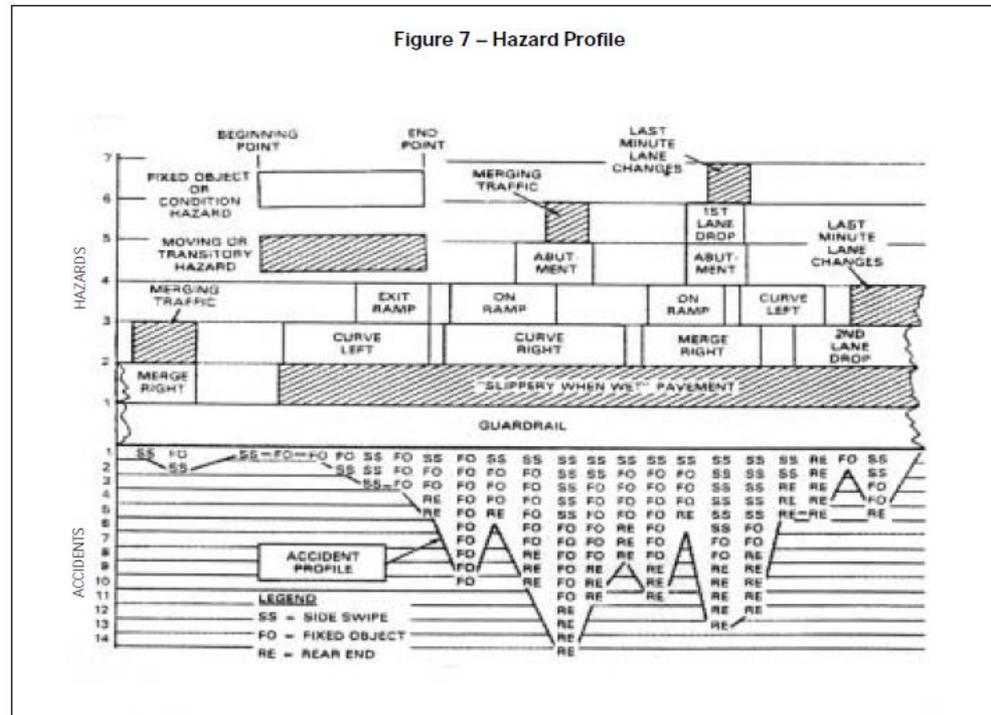
Hazard Clusters

- Often several hazards occur in such close proximity they may be considered one hazard

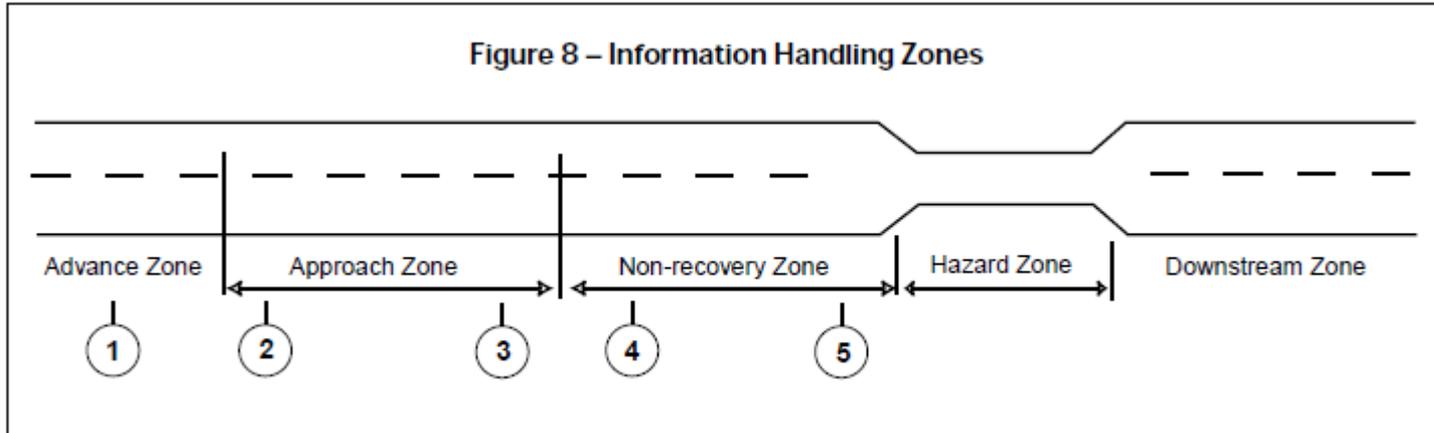
Rating Hazard Visibility

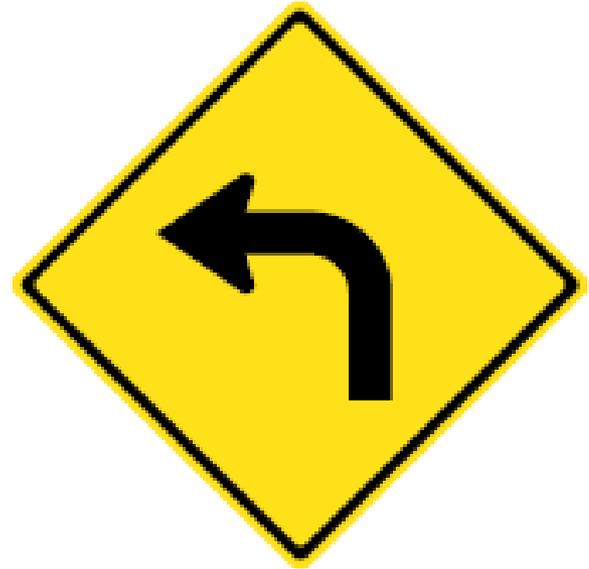
- The Sharp Curve Wa-2 or Wa-102 sign is to be used at locations where the final speed around a curve is less than the posted speed (a speed advisory tab may be required) Table 5 Book 6
- If the final speed is 10km/hr less than the posted speed table 5 recommends that a Advisory Tab is not required
